**North American Society for Trenchless Technology (NASTT)
NASTT's 2014 No-Dig Show**

TM1-T2-04

**Can You See It Coming? Examining and Mitigating the Common
Causes of HDD Failures**

Blake Peters, PE, McKim & Creed, Sarasota, FL
Jeffrey S. Lowe, PE, McKim & Creed, Clearwater, FL
Seton Katz, PE, Sarasota County Capital Management Services, Sarasota, FL

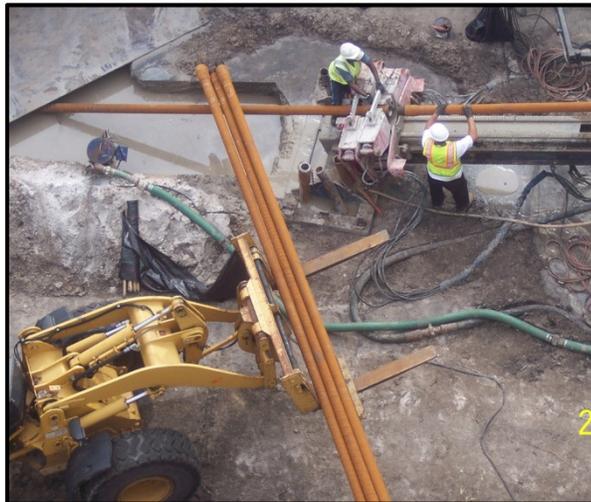
A second failure occurred during reaming the pilot hole. A rod was brought on site without first being inspected as required in the specifications. The rod was clogged with cemented bentonite when it was threaded into the drill string. There were five days of downtime to find and remove the failed rod once the clog was discovered. The risk of losing the drill head and GPS steering tool was high due to the prolonged lack of mud flow and setting bentonite. Drilling proceeded following the delay without the loss of drilling tools, but the avoidable oversight caused financial loss and frustration to all parties and put the project at risk of a much bigger failure.

Figure 1. Clogged rod that caused a failure.

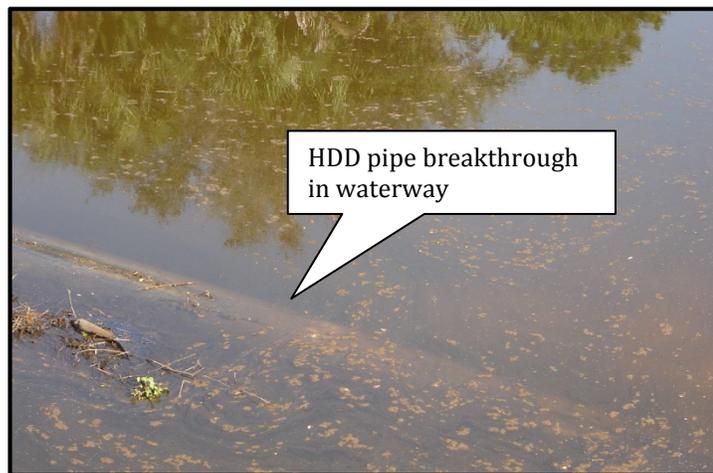
Figure 2. HDD pipe breakthrough in waterway

The second failure occurred because the waterway crossing was too short, making the radius of curvature aggressive. Also, the overburden was shallow and soft. The drill was initially completed, but shortly after installation the pipe was found floating in the waterway after it had broken through the soft soils, as shown in Figure 2. This line was subsequently re-permitted and installed as an open cut with precast ballast and bottom protection at a substantial cost. In addition to these capital losses, the project was delayed for an extended period.

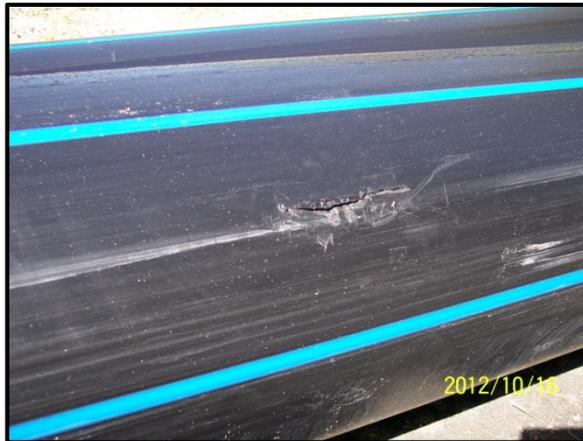
There are two primary failure types of concern when rollers are considered: damage to the pipe by yielding due to excessive force applied by the drill rig or pipe wall surface damage caused by the ground that decreases pipe wall thickness, as shown in Figure 3. If the pull force dictates the need for rollers and rollers are not feasible, then using a thicker wall pipe may be required. These types of issues should be identified early during construction and be coordinated with the contractor so the appropriate pipe is provided.

Figure 3. HDPE Surface Damage.

The decision to use rollers to protect the pipe from damage as it slides over the ground surface depends on the type of ground surface and the ability of the contractor to successfully keep the pipe on the rollers. Given its thick wall and robustness, the use of HDPE pipe is particularly useful in situations when the pipe will be subjected to surface damage. Steps must be taken to protect both the pipe and surface improvements.
